737 GRAPHITE COMPOSITE FLIGHT SPOILER FLIGHT SERVICE EVALUATION

FIRST ANNUAL REPORT
JULY 1973 THROUGH MARCH 1975

Prepared under contract NAS1-11668 by
BOEING COMMERCIAL AIRPLANE COMPANY
P.O. Box 3707
Seattle, Washington 98124

May 1975

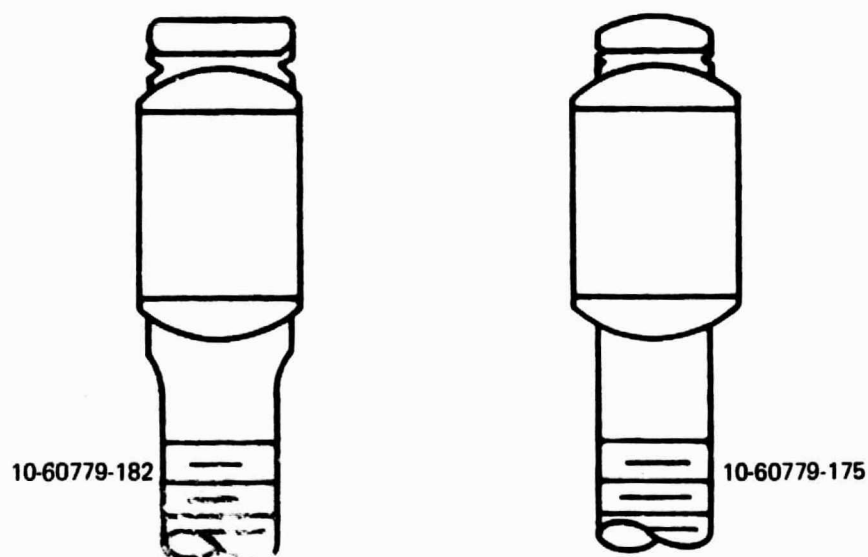
Figure 5.—Actuator Rod End Cross Sections

The most significant problem area has been the occurrence of upper surface skin blisters. This problem has been investigated and determined to be the result of an interference between the actuator rod end and the inner surface of the upper skin, when the rod end is in the "hard-over" position. Since the graphite skin is thicker, ≈ 0.091 vs 0.081 cm (≈ 0.036 vs 0.032 in.), and stiffer than its counterpart on the production aluminum spoiler, the graphite skin cannot accept the forced deflection without suffering an interlaminar shear failure. This type of problem was first noted in October 1973 on an Aloha 737. After the third such incident was reported in July 1974, a fleet survey of Aloha was conducted by the program technical leader. This survey disclosed six additional spoiler blisters not previously reported. Discovery of the rod-end interference problem led to a program-wide survey of all participating airlines to assess the extent of blister damage. This survey (October through November) disclosed three additional blistered spoilers on aircraft of two of the other airlines.

The immediate corrective action available was to replace the offending rod ends with the optional rod end which offers a spherical housing configuration (fig. 5). Replacement rod ends were furnished to Aloha, and rod ends for the remaining airlines were distributed during the January 1975 inspection tour.

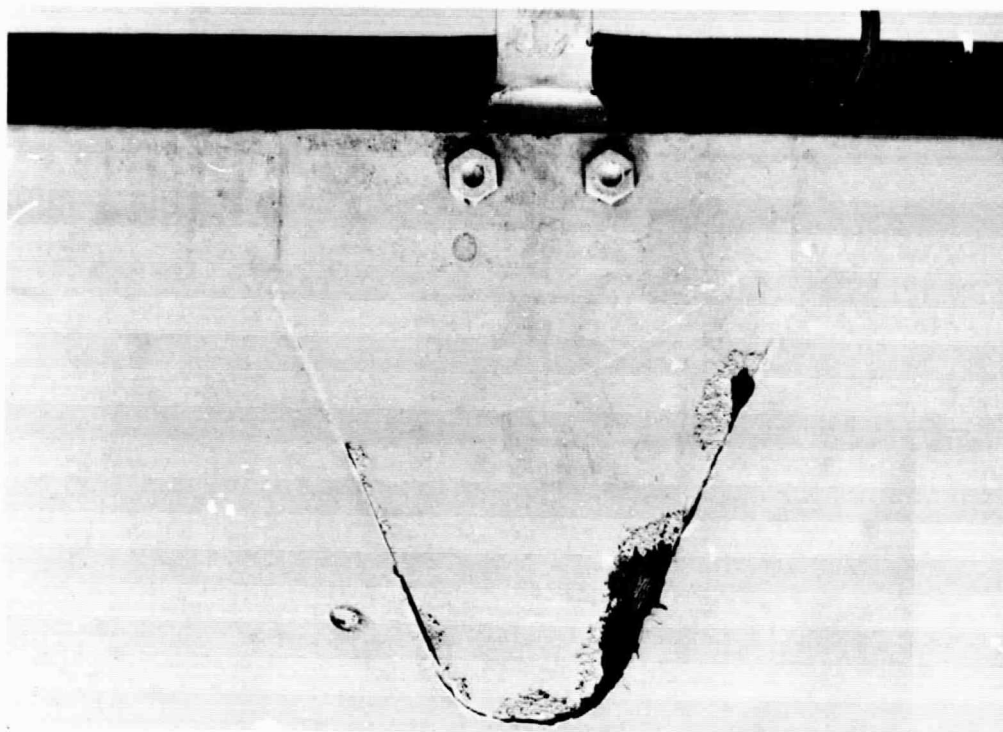
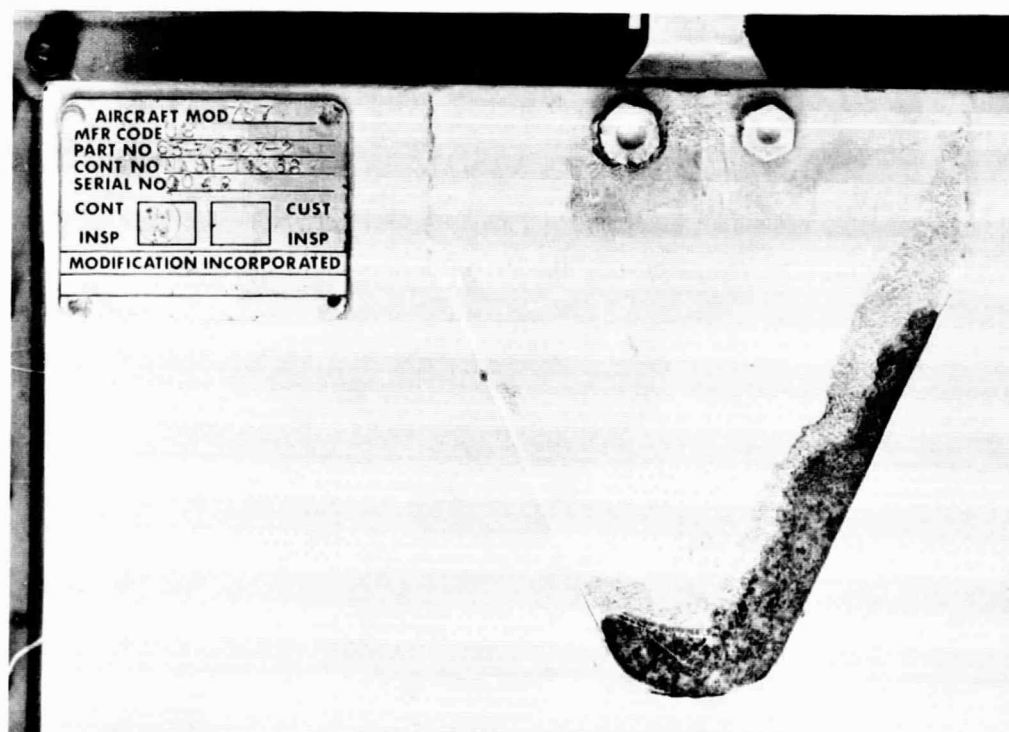
Figure 6.—Corrosion on -23 Doubler

the laminates points out very clearly that extreme caution must be exercised to avoid undesired forced displacements of the laminates. No evidence of corrosion or deterioration of the skin laminates has been observed. One case of corrosion of the aluminum bearing doublers on the spoiler lower skin was observed (spoiler S/N 0048, fig. 6). Investigation of this condition is continuing.

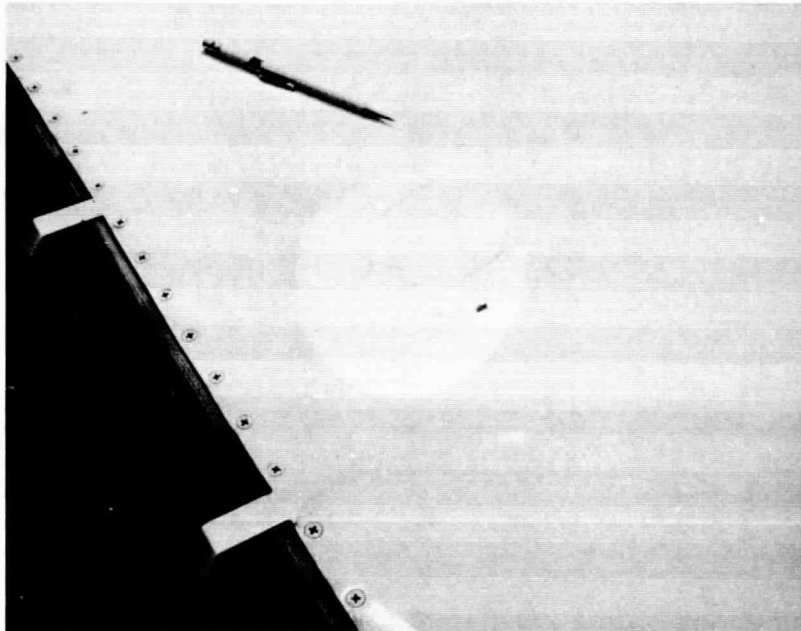
Figure 7.—Upper Surface Repair Delamination on S/N 0014

Five spoilers were selected at random for removal following the first year of service. Visual inspection of these units showed no detectable defects and only the oil and dirt associated with trailing edge components, except for spoilers S/N 0014 and 0104. Spoiler S/N 0014 showed evidence of delamination of a repair on the upper surface skin above the center hinge fitting (fig. 7). Spoiler S/N 0104 showed an upper surface skin blister, approximately 3 cm (1.2 in.) in diameter, above the center hinge fitting (CHF), which was not repaired prior to its destruction in static test.

All five spoilers were reexamined by ultrasonic testing techniques in the same manner as was employed in the original fabrication process. Comparisons between the two sets of ultrasonic recordings showed no detectable internal defects or disbonds and confirmed the external defects on S/N 0014 and 0104 which were visually noted.

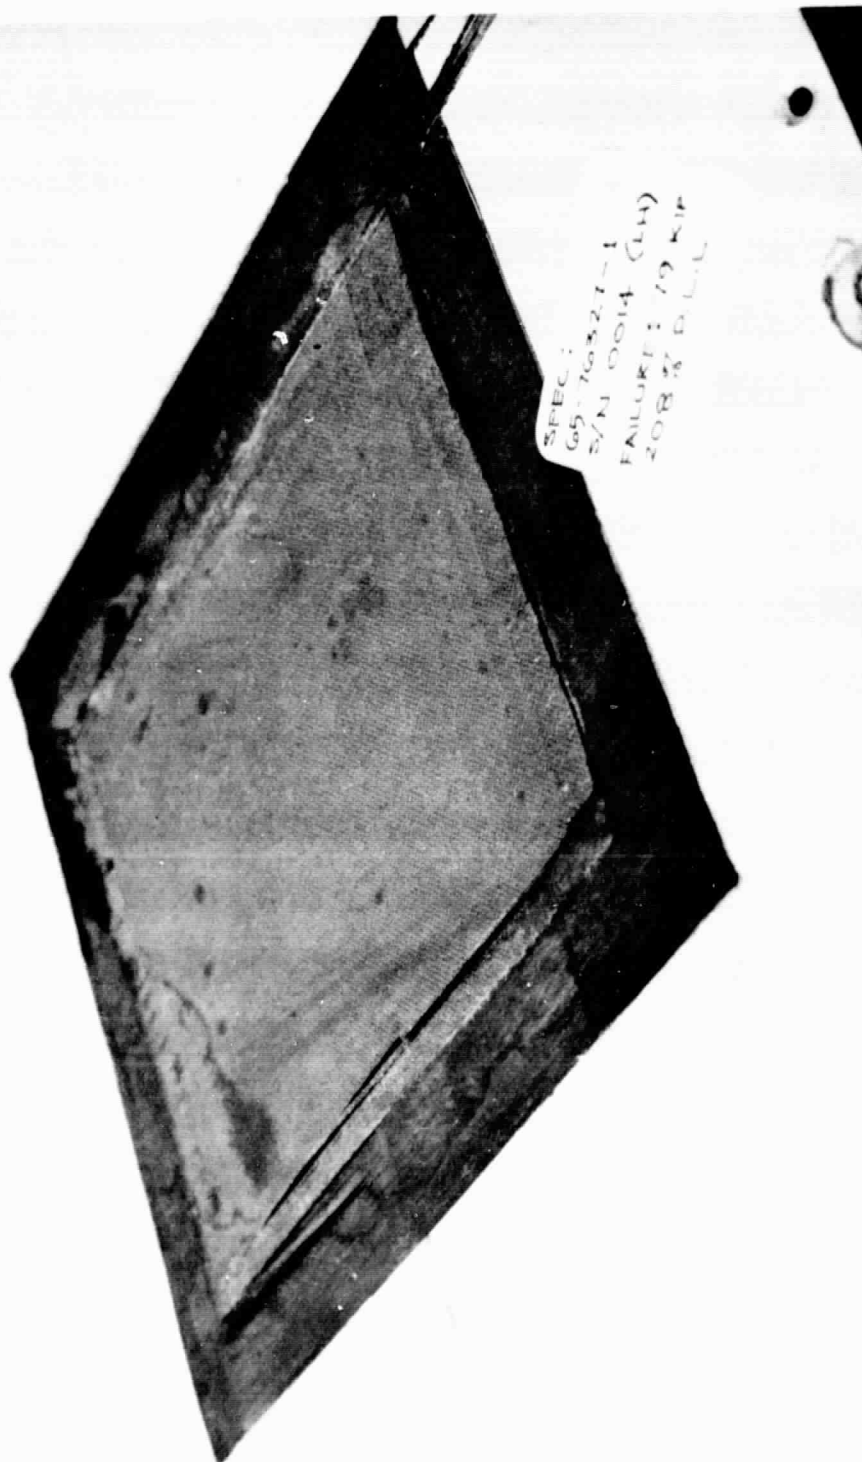
Figure 11.—Failure of S/N 0014 Through Repair

1. Initial failure of S/N 0014 was brought about by the combination of shearing of the -11 aluminum doubler above the CHF and failure of the repair patch on the upper skin above the CHF. The failure load achieved was attained despite a "resin only" joint around the edges of the repair. Repair procedures have been modified to include EA 9628 adhesive in the repair lap joints. Although the failure occurred in the skin repair area, the percentage loss in failure load was essentially no greater than for the other two test specimens. Failure of the comparable certification test spoiler (S/N 0002) was attributable to lower surface skin buckling near the CHF due to deflection of the CHF.

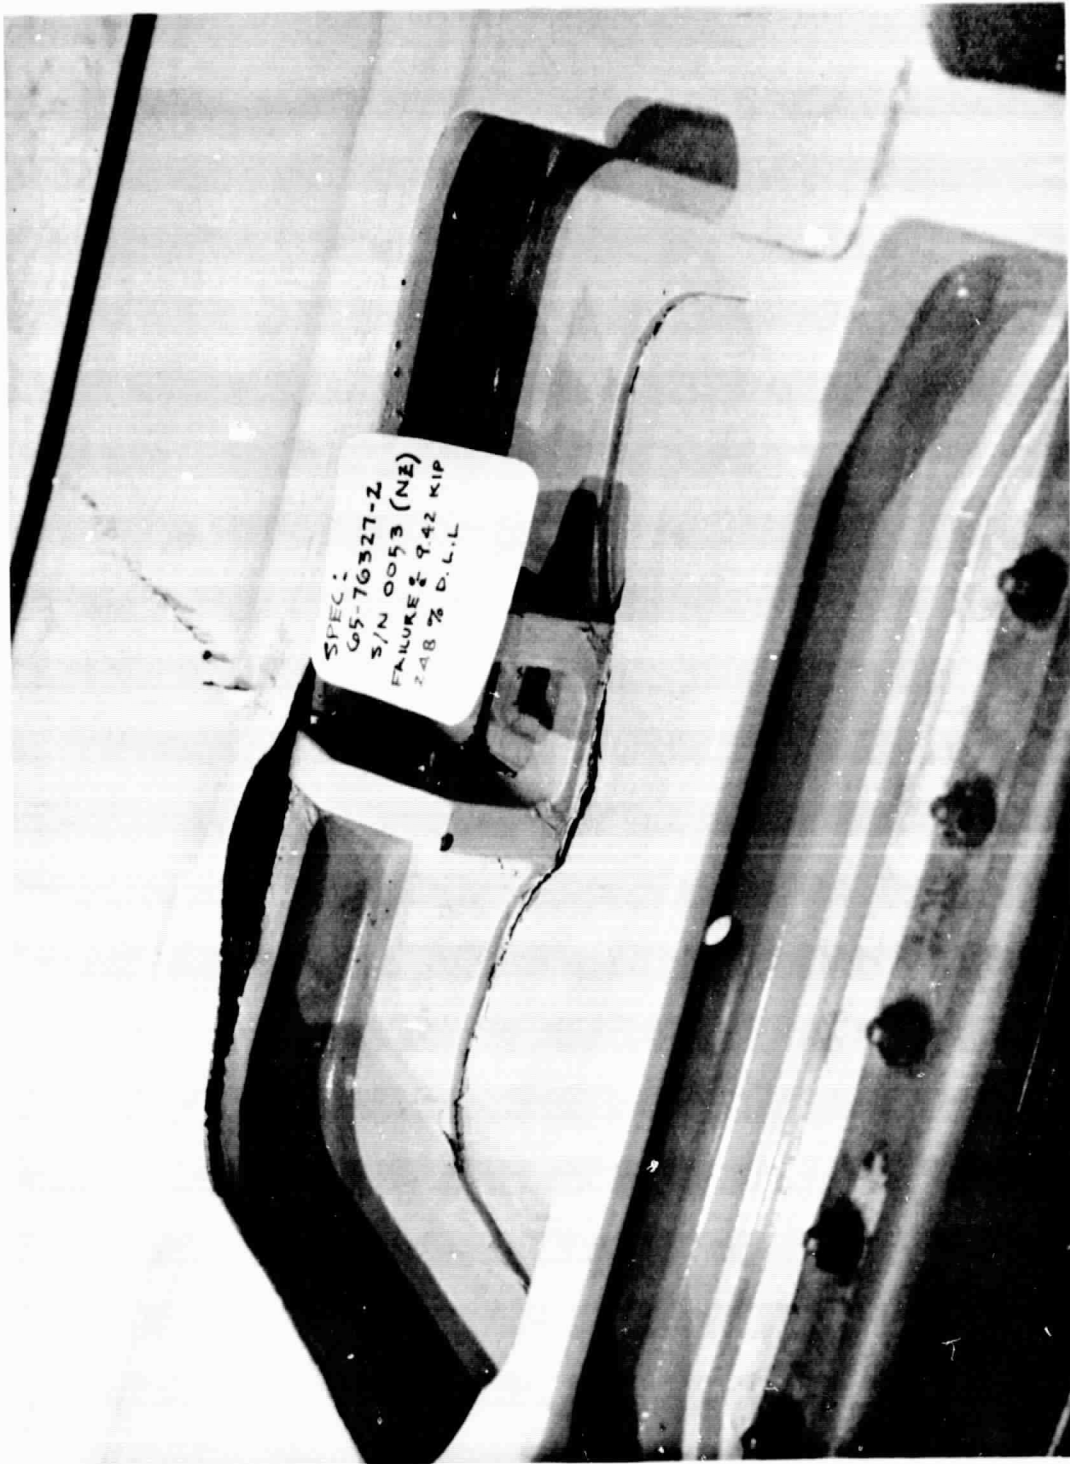
Figure 12. —Failure of S/N 0053 Above and Below Center Hinge Fitting

2. Failure mode of the T300/5209 spoiler (S/N 0053) has been assessed as a primary lower skin buckling immediately adjacent to the CHF. An additional failure of the -11 aluminum doubler under the upper skin precipitated the upper skin tension failure. Both failures were influenced by deflection of the CHF. Failure of the comparable certification test spoiler (S/N 0041) was attributed to upper surface skin tension failure precipitated by yielding and failure of the CHF.

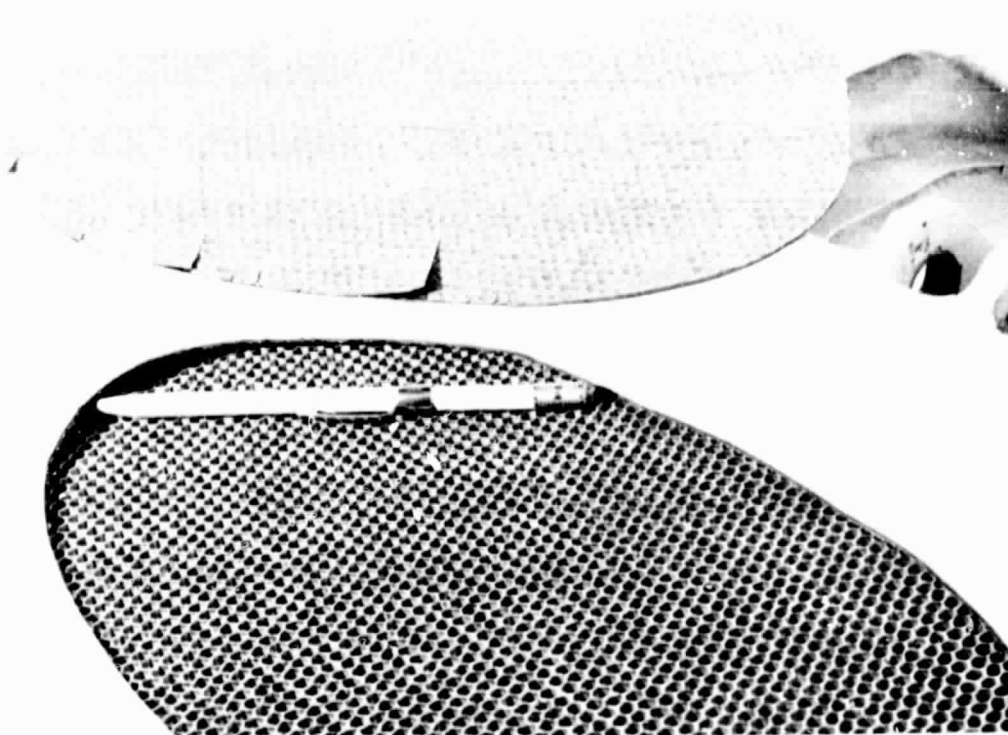
Figure 14.—Skin Removed From S/N 0024

In one instance (S/N 0024), the spoiler, with the upper skin repaired, was not placed in the bonding assembly tool. Instead, a partial bag was prepared covering the repair only. Following autoclave cure and bag removal, a large oval-shaped void, approximately 20 x 30 cm (7.8 x 11.7 in.), was visually noted in the central portion of the lower skin.

The color scan which followed the repair confirmed the void. To visually assess the problem, an oval section of skin was removed (fig. 14). Further examination disclosed that those areas adjacent (in the spanwise direction) to the initial void were also voided or weakly attached. Progressive removal of the entire lower skin was successfully accomplished (fig. 15). An entire new lower skin was successfully bonded to the spoiler frame, with the subsequent NDT inspection showing a void-free bondline. Following the repainting and reinstallation of details, the spoiler was returned to service.

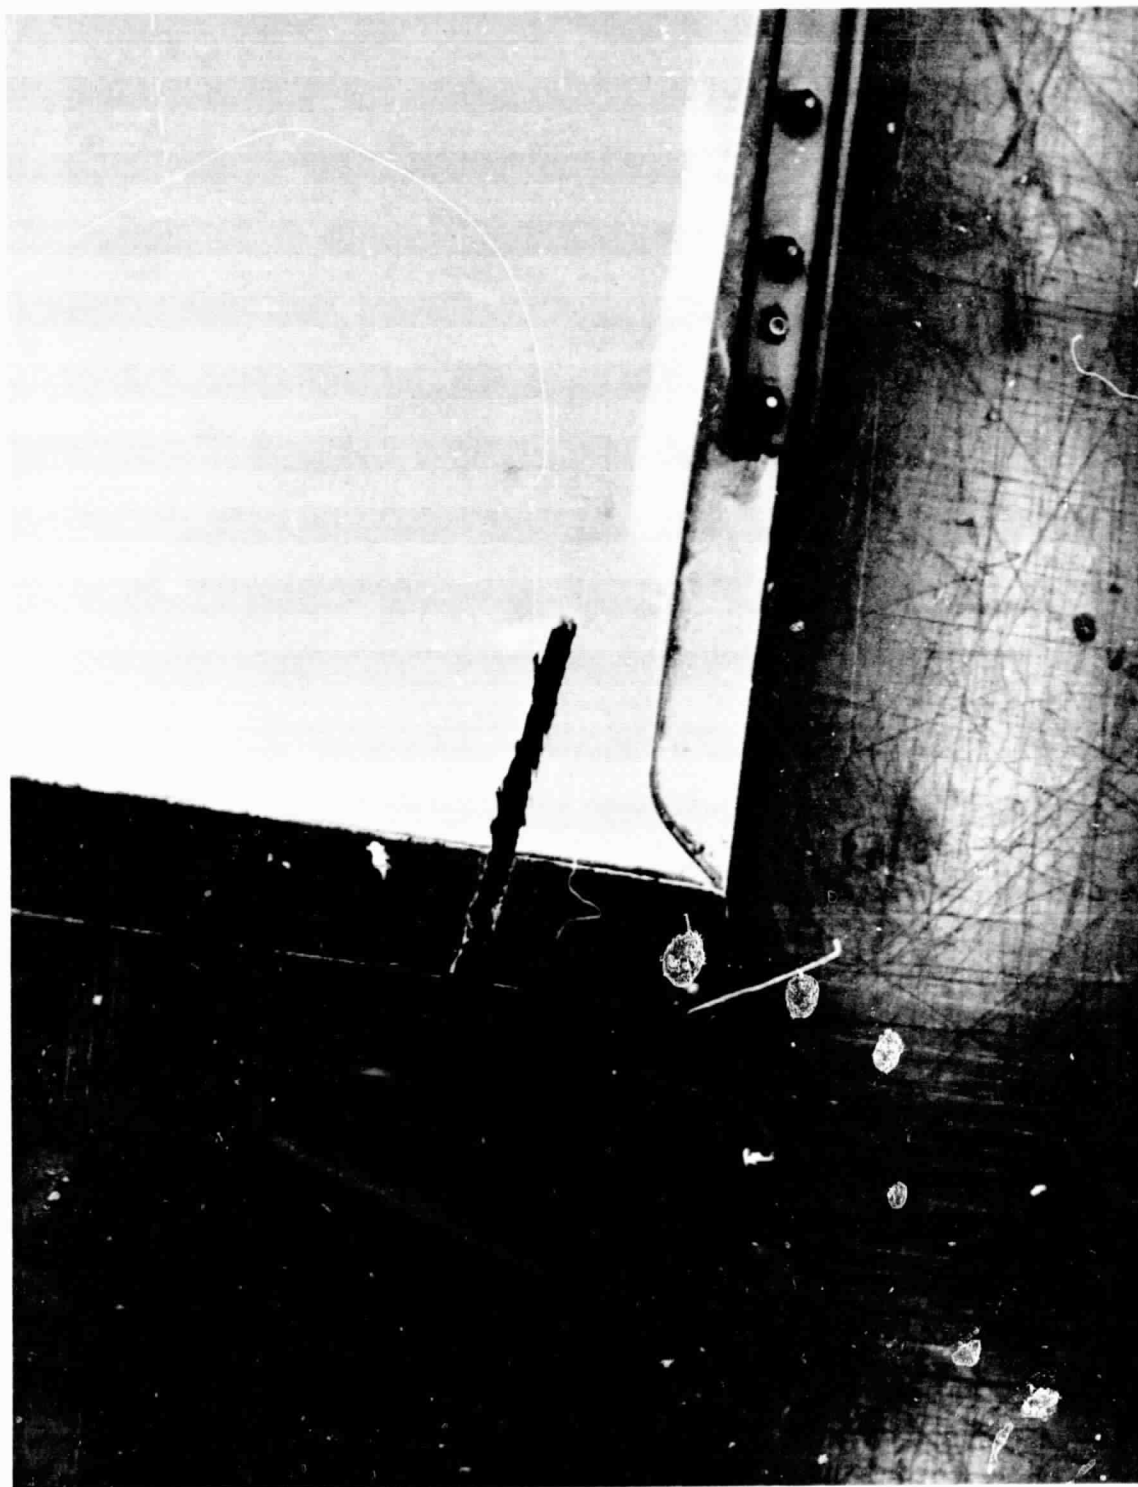
Figure 16.—Damaged Trailing Edge of S/N 0089

In June 1974, New Zealand National Airways reported that spoiler S/N 0089 had been inadvertently damaged by a control cable during aircraft overhaul. The nature of the damage was a slot cut through the spoiler thickness for a length of approximately 6.6 cm (2.6 in.) from the trailing edge. This damage has been repaired by Boeing, and the spoiler has been returned to National Airways and reinstalled.

Photos of the New Zealand spoiler (S/N 0089) show the damaged trailing edge before repair (fig. 16) and after repair (fig. 17).
